Model	Model Code	Year Model
CIVIC 5D	FK1, FK2, FK3	15, 16
CIVIC 5D TYPE R	FK2	15, 16
CIVIC TOURER	FK2, FK3	15, 16, 17
CR-V	RE5	15, 16, 17, 18
CR-V DIE	RE6	15, 18
CR-V I-DTEC	RE6	16, 17
HR-V	RU1, RU8	16, 17, 18
JAZZ	GK3	16, 17, 18

Issue Date  
24/02/2018

## Honda Connect Software Update (RC8)

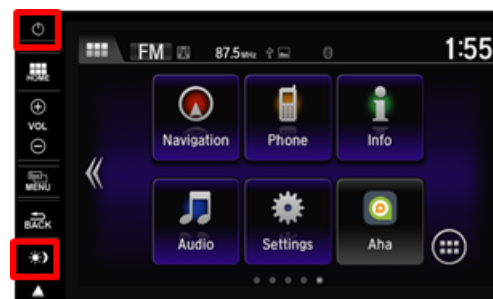
Some units might experience "H screen stuck on" symptom. Initially the software update will not be possible when the unit is "H screen stuck on". You will need to follow these steps before attempting the update:

**Note: The "H screen stuck on" symptom can be caused by software or a hardware failure. In case of a hardware failure, recovering is not possible and a new RM unit is necessary.**

- When unit is in fail mode "H screen stuck on", Press and hold the Power and Day Night button at the same time for five seconds.

**Note: Wait until the loading circle appears on the screen and then press the Power & Day Night button.**

- After five seconds the unit will switch into the reboot mode, then the unit will do a file check during rebooting. Rebooting will take approximately two and a half minutes.
- Now continue with software update procedure.
