Helping you fix it right the *first* time - *every* time

## Subframe Adapter PWK07AODYS0 No Longer Available

**Currently Applies To:** '99–04 Odyssey

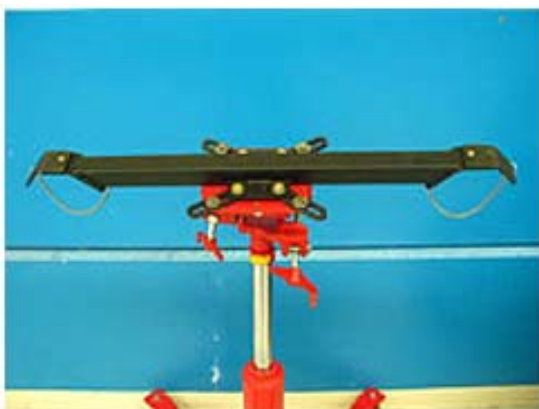
T/N PWK07AODYS0

Ordering Subframe Adapter (T/N PWK07AODYS0) from the Honda Tool and Equipment Program? You'll find it's no longer available. This tool has been superseded by the Universal Subframe Adapter (T/N VSB02C000016) and it's being removed from the list of required tools for Honda dealerships.

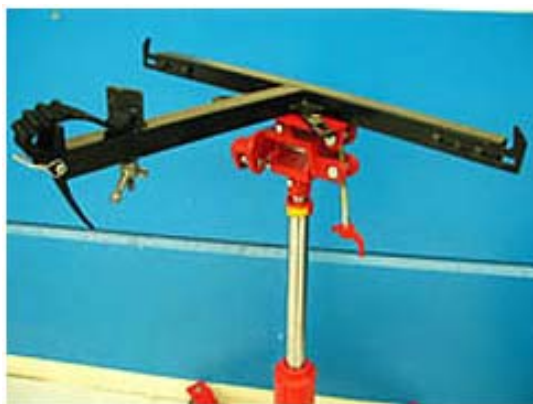
T/N VSB02C000016

The VSB02C000016 has enough adjustability to handle the subframes in these Odysseys.

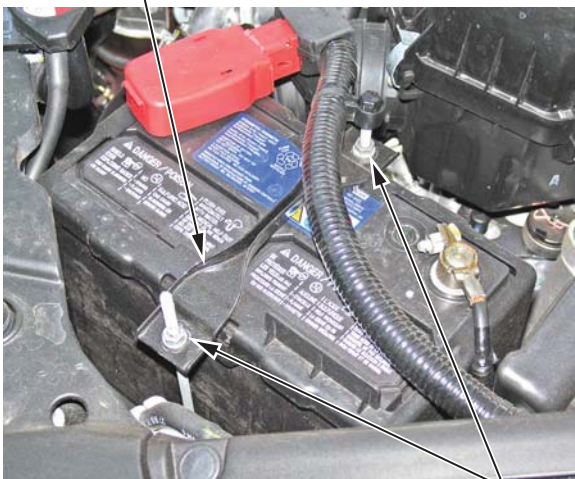
Installing a battery? Take it easy on those hold-down nuts. If you overtighten them, you'll put too much stress on the battery case, which can cause it to deform and the inner seals to separate. Leaking inner seals can shorten battery life.

HOLD-DOWN

NUTS

A good rule of thumb to follow is to tighten the nuts just enough so the hold-down doesn't budge when you try to wiggle it.

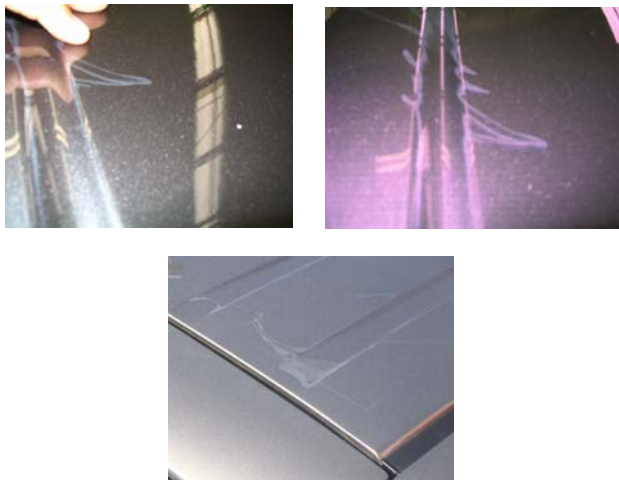
Trapped moisture under the Wrap Guard white plastic protective covering can penetrate the clear coat, making even the best factory paint job look stained, fogged, or discolored. Here's what trapped moisture looks like on bodywork with the Wrap Guard removed:

Fortunately, there's an easy fix for this problem, and all you need is a heat gun. Just carefully warm the paint with the Wrap Guard or plastic covering removed, and that trapped moisture evaporates. To avoid damaging the paint or any nearby plastic or rubber parts, apply the heat in a circular motion over the affected area and make sure the surface temperature stays **under 180°F**.

You may need to do this heat treatment more than once to get rid of that moisture . . . so just be patient and take your time.

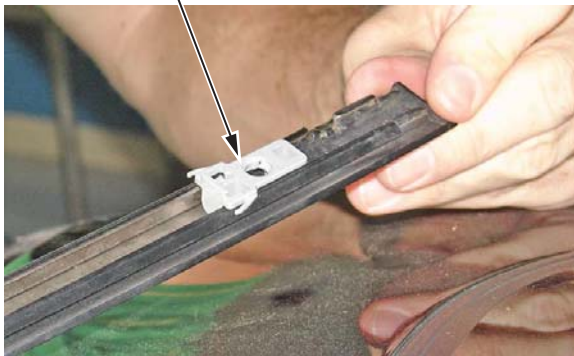
Install front clip to roof molding.

1. Starting at the front, use a trim tool with a shop towel to pry up the roof molding, then slide it forward to release it from under the rear roof trim.
2. Use a pair of long-nose pliers to remove the three clips from the roof channel. Discard the clips.
3. Install a new front clip onto the roof molding with its hooks facing toward the rear.

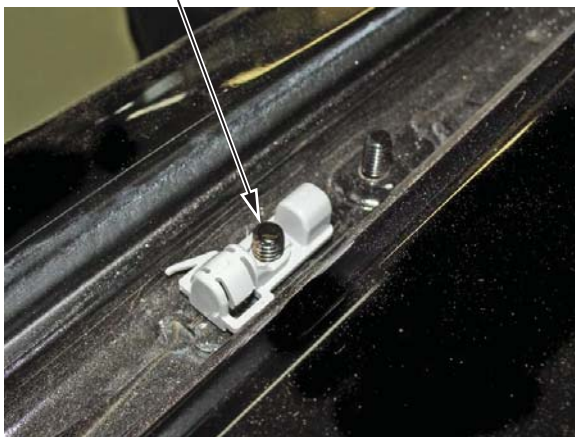
Install clip on rear stud.

4. Install new center and rear clips onto the **rear** studs of the roof channel with their hooks facing toward the rear.

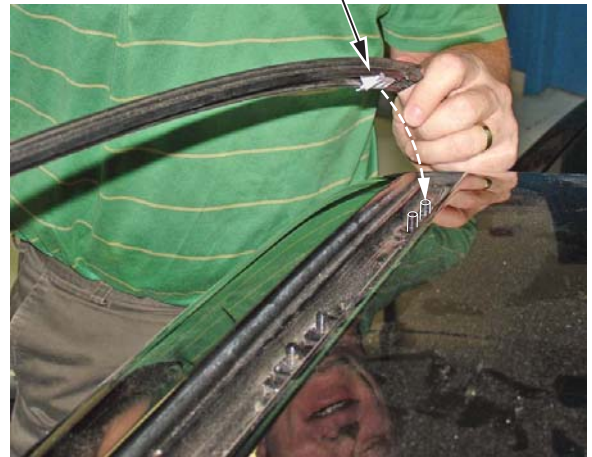
Align hole in clip with the front stud.

6. Starting at the front, carefully line up the hole in the front clip with the **front** stud in the roof channel. Then working your way back, push down on the molding so the center and rear clips snap firmly into place.

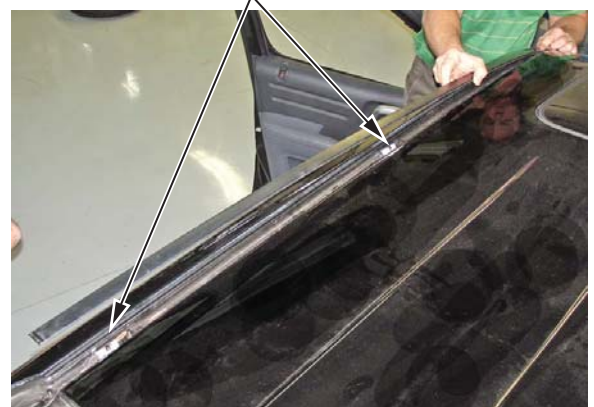
Snap the clips into place.
